## Understanding Friction Cracking and its

causes

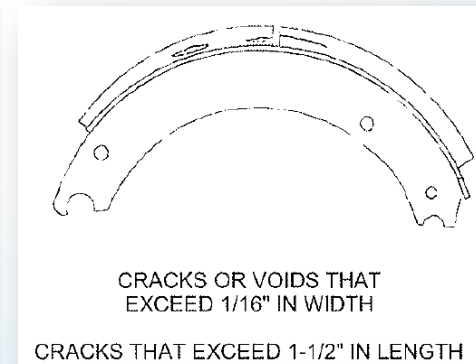
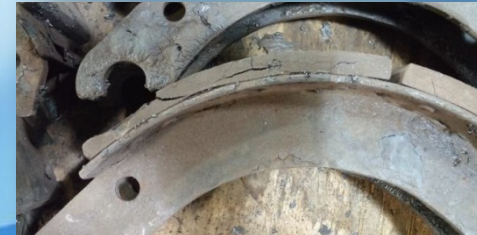
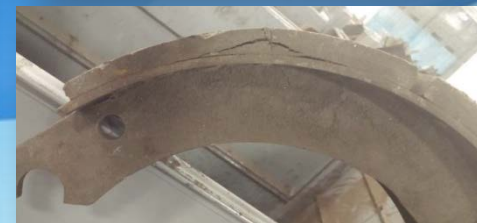
## Horizontal Edge Cracks

**Appearance** – delamination, appears to be a separation of layers within the friction.

- Poor friction integrity
- Surface of the friction heats more rapidly than the base, expansion causes friction to delaminate
- Higher quality frictions are more dimensionally stable and have more structural integrity to mitigate this issue
- Low quality frictions with low flexural strength

**Solution** – Make certain your supplier is capable of testing friction and ensuring that it's capable of holding up in the application. In particular, make sure that they are paying close attention to flexural strength.

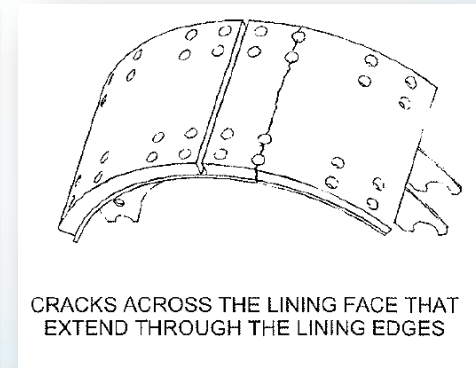
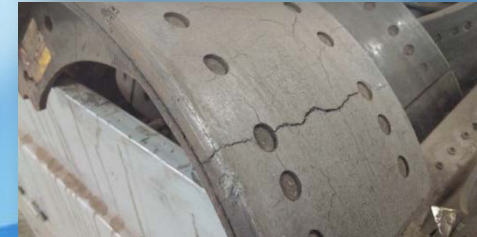
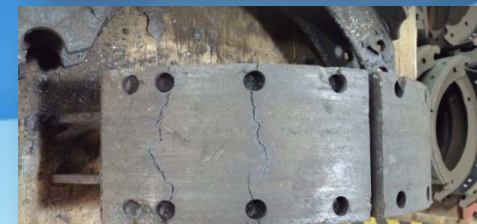
## Vertical Edge Cracks

**Appearance** – Cracks extend vertically up the sidewall of the friction and travel directly across the face of the friction.

- Un-coined shoe--the friction is being forced to conform and the stress is cracking the friction
- Poor flexural strength of the friction
- Mismatch of geometry between the shoe and friction block, possibly due to issues with the grind of the friction or shape of the shoe

**Solution** – Make certain the remanufacturer you are selecting is coining all shoes and has a full understanding of the dimensions of the brake shoe, most likely learned through OE design and production.

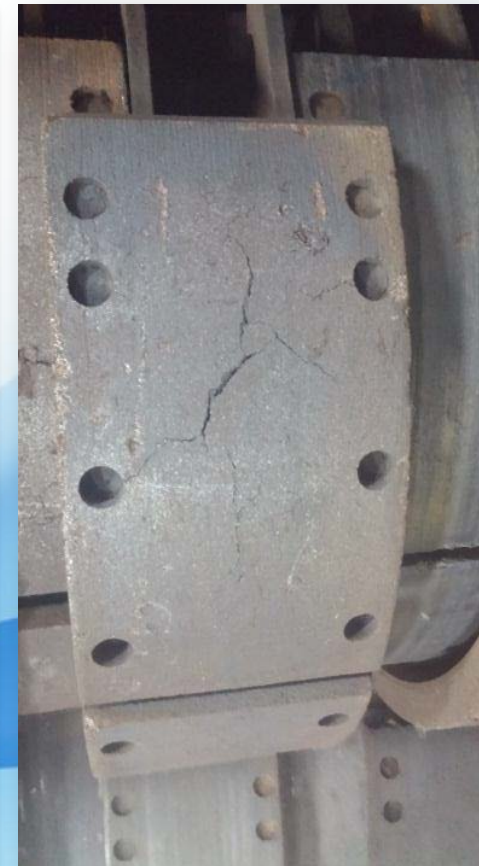
## Spider Web Cracks

**Appearance** – Spider web from central point.

- An elevated point (Stress Riser) under the friction has created a pressure point
- Poor flexural strength – friction can't hold up to inherent imperfections in the brake
- Corrosion – inadequate coatings to resist environment
- Poor friction fit allows contaminants to enter, leading to corrosion

**Solution** – If the shoe appears heavily corroded, make certain your selected remanufacturer is properly cleaning, blasting and coating shoes to an OE level process.

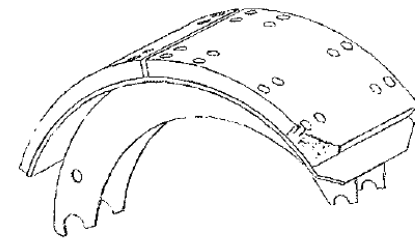
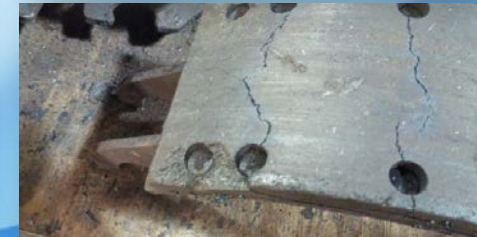
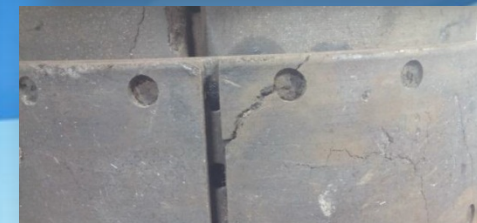
## Cracking and Chunking resulting in missing friction

**Appearance** – A crack so severe it results in a section of missing friction, often times corner or edge of the friction is broken off.

- Severe crack – lack of coining
- Missing corner – lack of coining or debris
- Low flexural strength – the friction cannot mechanically hold up to the stress of the application

OUT OF SERVICE PORTION OF  
LINING MISSING THAT EXPOSES  
A FASTENING DEVICE

**Solution** – Select a friction supplier that coins 100% of shoes and offers friction with high flexural strength.

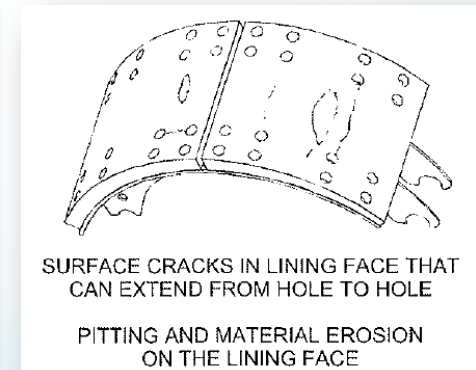
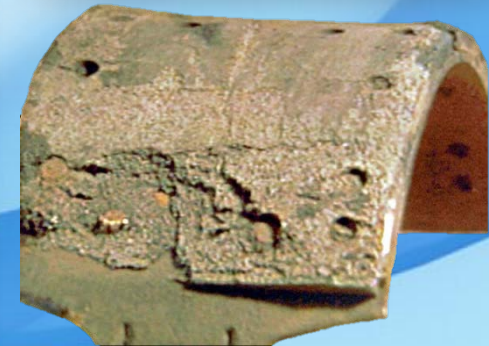
## Pitting and Crumbling resulting in missing friction

**Appearance** – Severe degradation and pitting of the surface. May have a charcoal-like appearance as the friction is burning out and becoming porous.

- Low quality friction made with low temperature, cheap resins
- Improperly rated friction put into an application beyond its capabilities

**Solution** – Make certain the shoe supplier you select has research and development capability to fully understand the friction they utilize and can properly assign the application ratings.
